Supplemental Information & Instructions

for ID 24108 Front Crankshaft Oil Seal, Lip Type ID 24378 Gasket, Timing Chain Cover ID 24380 Gasket, Oil Pan (2 Pieces) MG TC, TD, TF

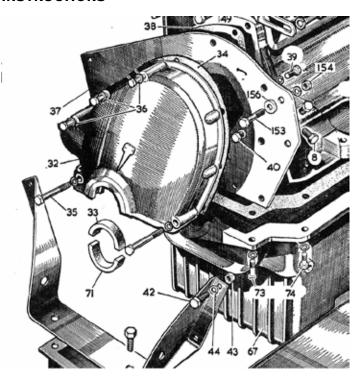
Illustration of the MG TF Engine from the Factory Parts Book.

The numbers in parenthesis in the instructions refer to the numbers in the diagram above.

- Look at the back of the timing cover and locate the open hole where one of the oil pan fixing bolts will go, Place a blob of silicone sealant over this open hole to prevent oil running down the threads and past the lock washer and bolt head.
- Secure the 24378 gasket (34) to the timing cover with a thin bead of silicone sealant.
- Squeeze a small bead of silicone sealant into the groove for the seal in the timing chain cover.
- Insert the seal in the timing cover groove as centrally as possible, making sure the open side of the seal faces the engine. The rubber seal is narrower than the groove; this is not a problem.

- Put a thin bead of silicone sealant on the other side of the timing cover gasket, then install the timing cover on the front of the engine but do not fully tighten the bolts. The timing cover is secured with seven 8 MM bolts of three different lengths. The two short bolts (39; 18mm long) enter from the rear. Of the five remaining long bolts, two are slightly longer and have thicker heads than the other three. These two slightly longer bolts (35; 51.5 mm long) go at the bottom of the cover, nearest the crankshaft. The remaining bolts (36; 44mm long) secure the right edge of the cover.
